# **OH-6A MISHAP EXPERIENCE REPORT**

## OH-6 MISHAP EXPERIENCE REPORT

1 July 1967 through 30 June 1971

LOH Division  
Directorate for Aircraft Accident Analysis and Investigation

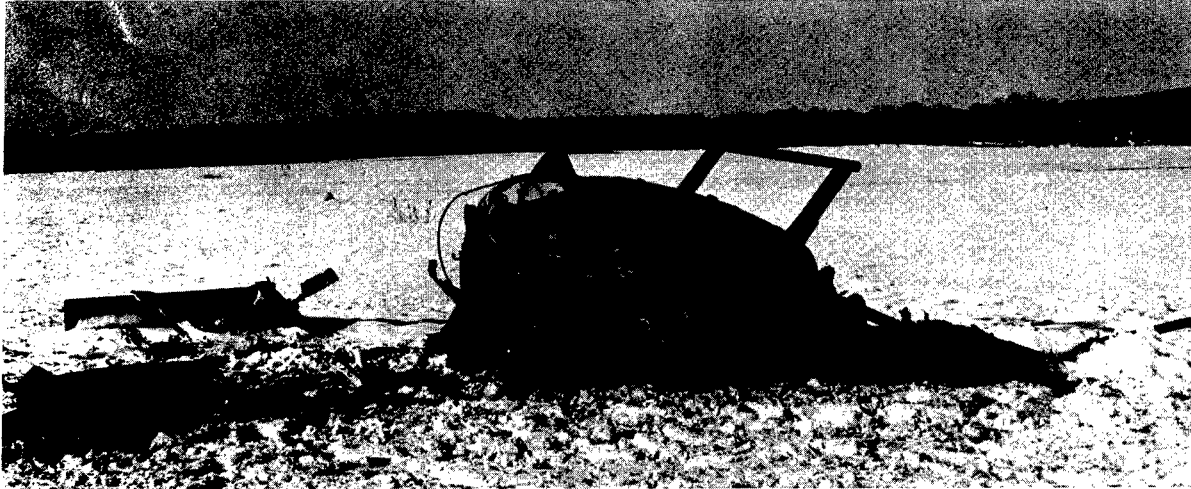
aircraft hit hard with a slight rearward motion and left side low. The two pilots sustained minor injuries and the aircraft was destroyed. The primary cause factor was listed as loss of ground contact due to heavy snowshowers and blowing snow from rotorwash. Suspected factors were a 30° wind shift, pilot disorientation, not making a go-around, and pilot's inexperience.

ACCIDENT NO. 1—Both pilots experienced vertigo in blowing snow.

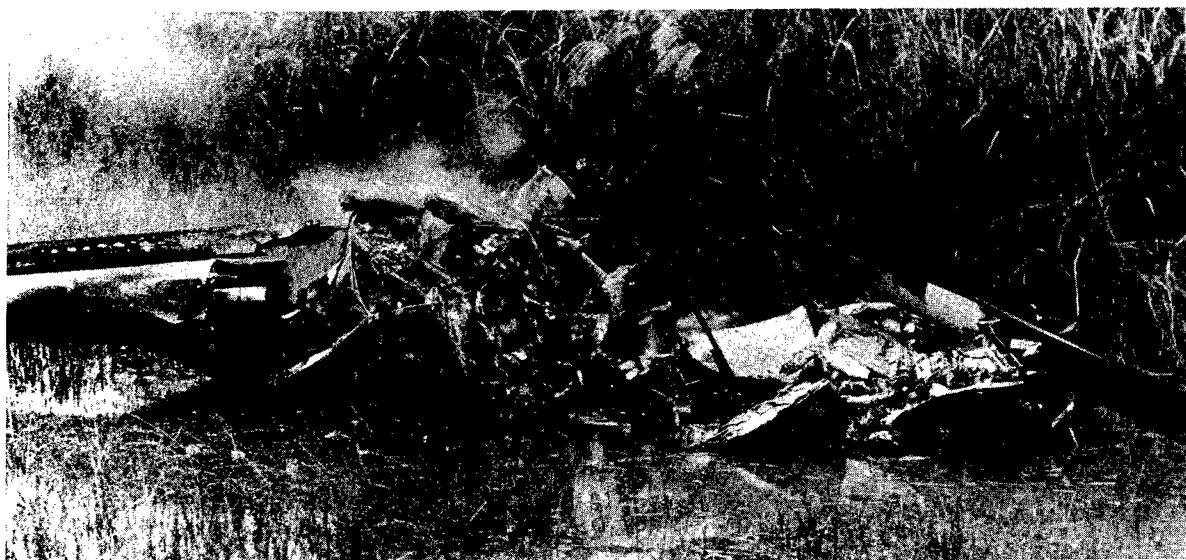
ACCIDENT NO. 6—Gunner was dropping fragmentation grenades from aircraft in attempt to destroy footbridge. Explosion occurred in passenger compartment and compartment was engulfed in flames. Explosive force knocked pilot's feet off pedals and broke out chin bubble. Emergency landing was made and pilot and observer escaped. Aircraft was consumed by fire with the gunner still in his seat. There was one fatality and one major injury. Aircraft was destroyed. Caused by gunner dropping live grenade on passenger compartment floor.

ACCIDENT NO. 6—Gunner dropped live grenade on passenger compartment floor.

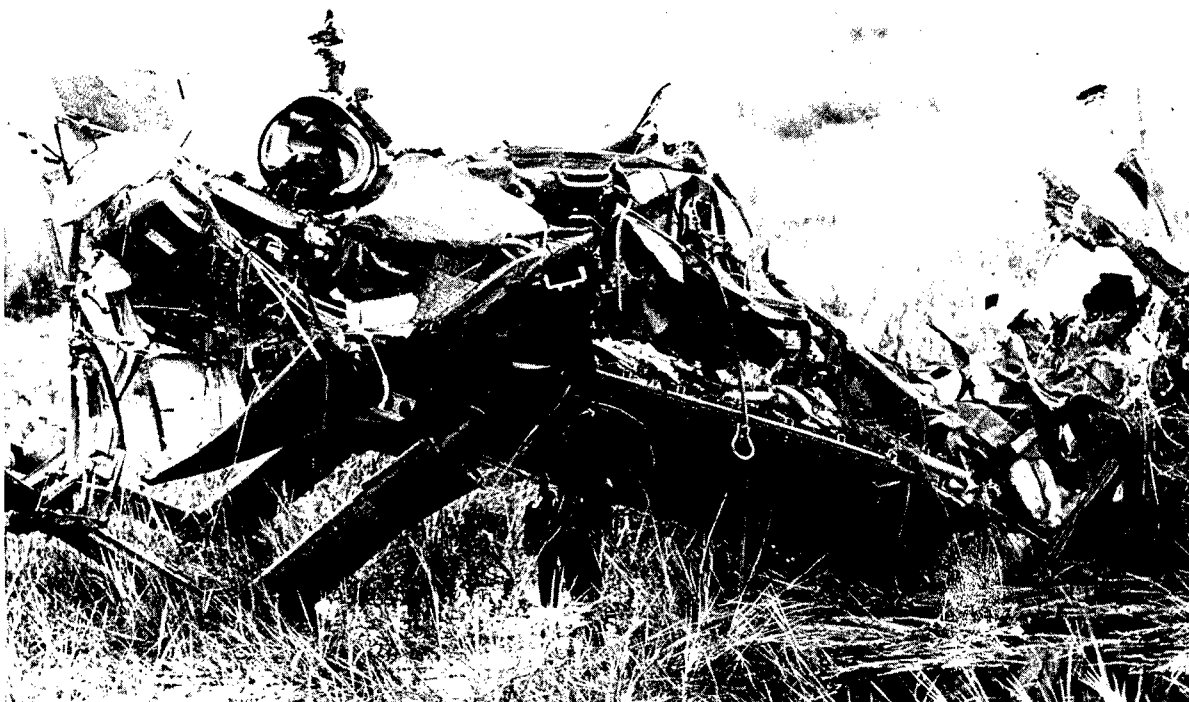
ACCIDENT NO. 7—Pilot accepted aircraft from maintenance and was returning it to his parent organization. Shortly after takeoff about 1730 hours, aircraft struck guy wire attached to 400-foot radio tower and disintegrated. The three occupants were killed. Suspect pilot was not familiar with the location of the towers and that the angle of the sun caused sun blindness.

ACCIDENT NO. 7—Aircraft struck guy wire attached to 400-foot radio tower.

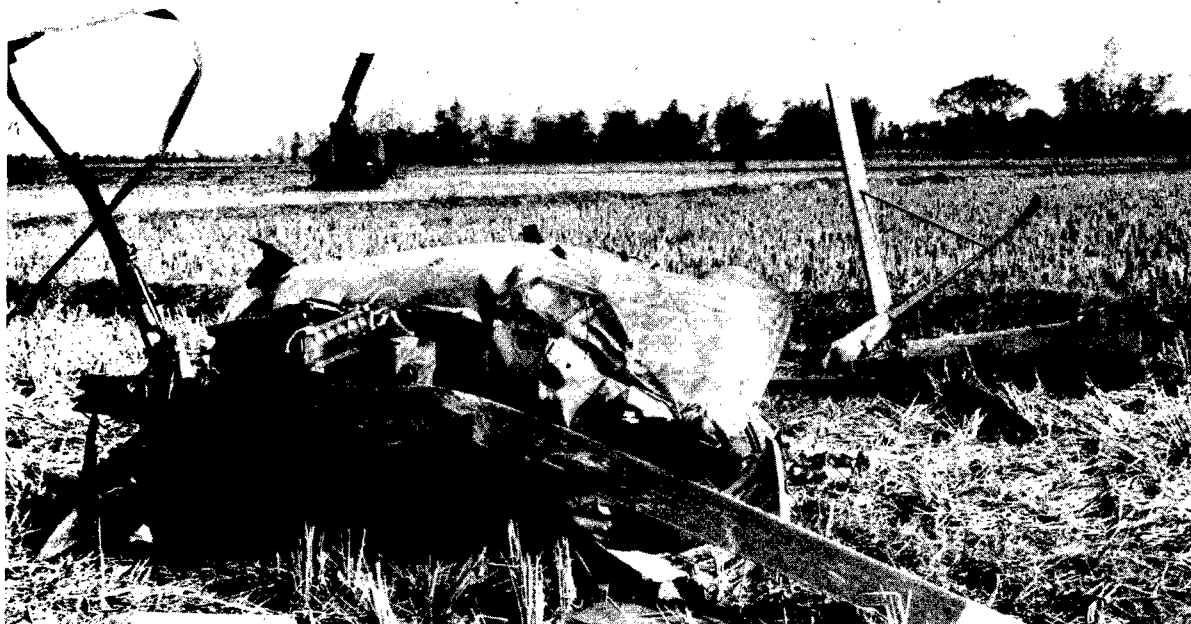
ACCIDENT NO. 9—Result of improper preflight, low fuel, and unnecessary and erratic low level flight.
